STRUCTURAL ENGINEERS REPORT
ON
FRONT ELEVATION WALL
AT
110 UPPER STREET, LONDON, N1 1QN
FOR
MR R. KILIKITA

Ref: 13027/AS/WM
Date: 18th April 2013

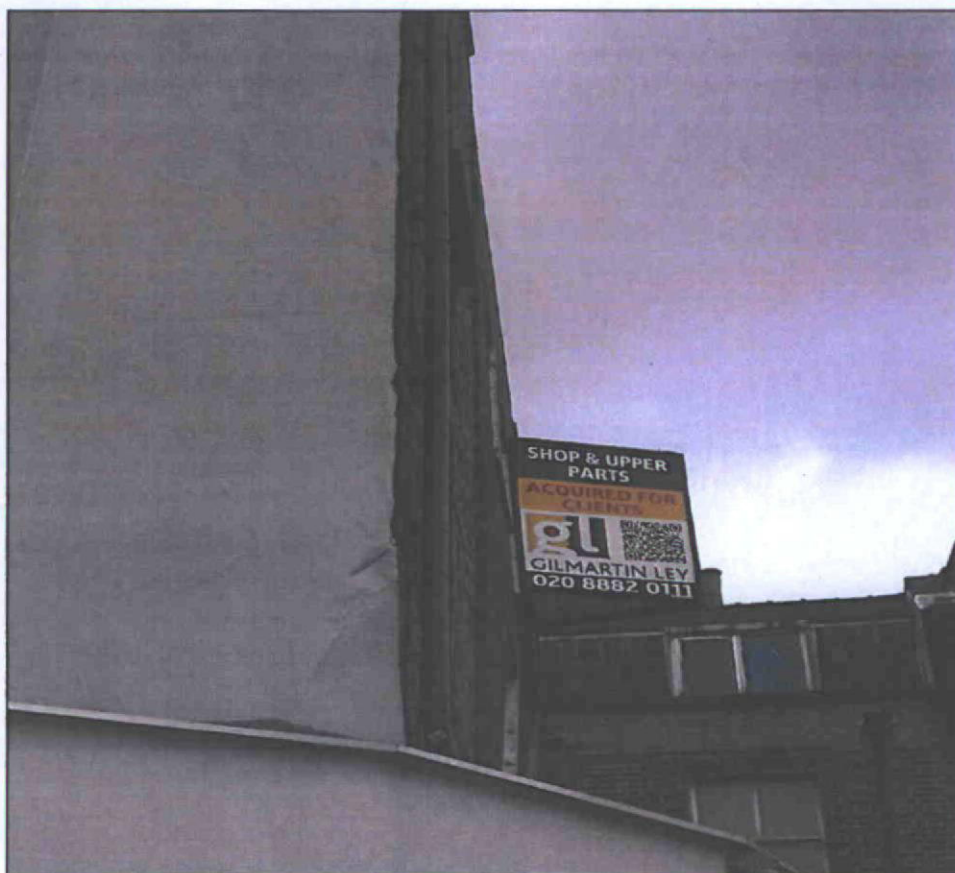
PHOTO 1

In general this wall is in an extremely poor condition with very old poor patch repairs, frost damaged bricks, damaged brick arches and with a very large bulge (over 120 mm) at second floor level. Please refer to photo 1.

Side view of front elevation showing bulge in the wall

- 4.1 Because of the extensive bulge, damage to the flat arches over the first floor window, frost damage and poor repairs to the front facade we would strongly recommend that this wall is carefully demolished and rebuilt in facing bricks to match adjoining properties.
- 4.2 Further input from ourselves will be required to prepare the design and detailing of the rebuilt front wall and supporting structure.

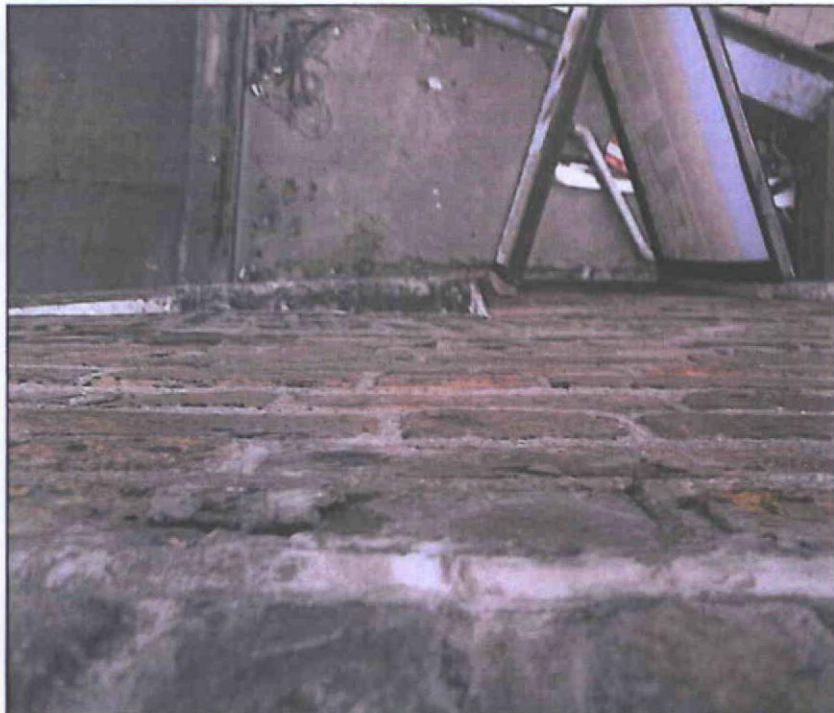
PHOTO 2

The front elevation wall was constructed as a solid wall but with an inner 215 mm thick skin in Fletton bricks or similar and with an outer 103 mm thick facing brickwork skin. The bulge has occurred due to the lack of tying between the two brickwork leafs and the lack of restraint at each floor level. Please refer to photo's 2 and 3.

**Front elevation view taken from second floor window
showing very poor condition of bricks**

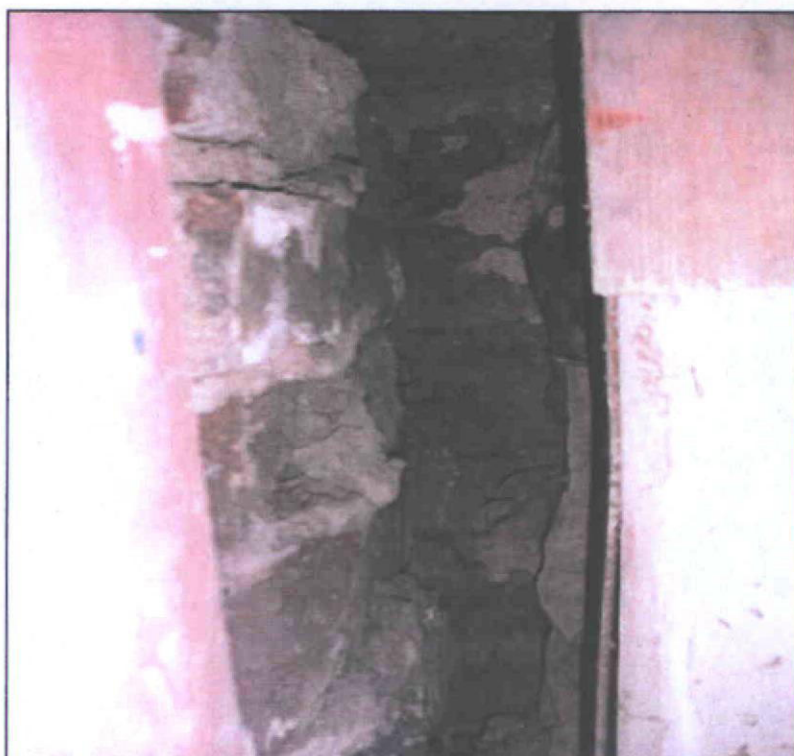
PHOTO 3

**Internal view of central wall pier at first floor level
showing inner 215 mm and facing 103 mm leaf**

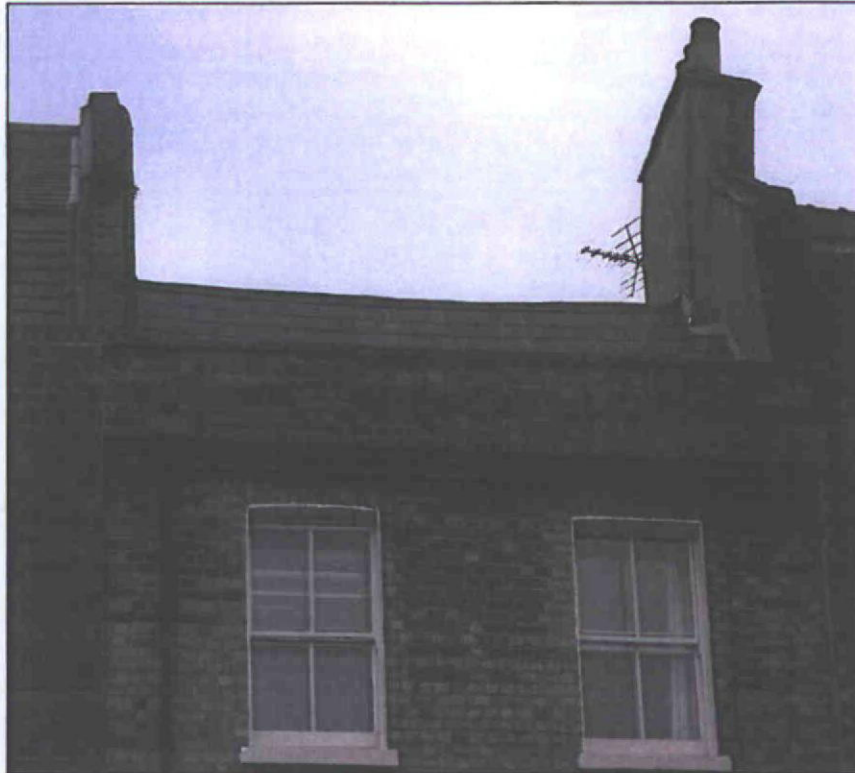
- 3.2 The masonry to the top of the wall is suffering from frost damage and requires extensive repairs. Please refer to photo 4.
- 3.3 The flat brick arches over the windows at first floor level have failed and would require re-building.

PHOTO 4
Top of front elevation wall showing different bricks
as well as frost damaged brickwork just below the parapet
