STRUCTURAL ENGINEERS REPORT
ON
FRONT ELEVATION WALL
AT
110 UPPER STREET, LONDON, N1 1QN
FOR
MR R. KILIKITA

Ref: 13027/AS/WM
Date: 18th April 2013

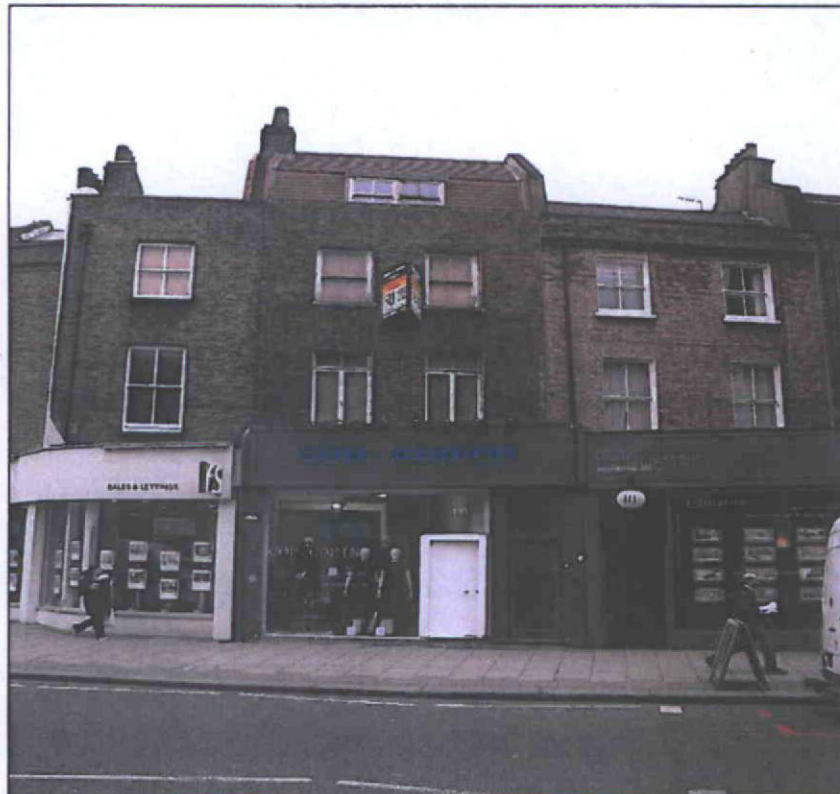
In general this wall is in an extremely poor condition with very old poor patch repairs, frost damaged bricks, damaged brick arches and with a very large bulge (over 120 mm) at second floor level. Please refer to photo 1.

- 4.1 Because of the extensive bulge, damage to the flat arches over the first floor window, frost damage and poor repairs to the front facade we would strongly recommend that this wall is carefully demolished and rebuilt in facing bricks to match adjoining properties.
- 4.2 Further input from ourselves will be required to prepare the design and detailing of the rebuilt front wall and supporting structure.
